Appendix 6

Photo Log

MS4 Mapping Discrepancies – City Operations Facility at Spa Road

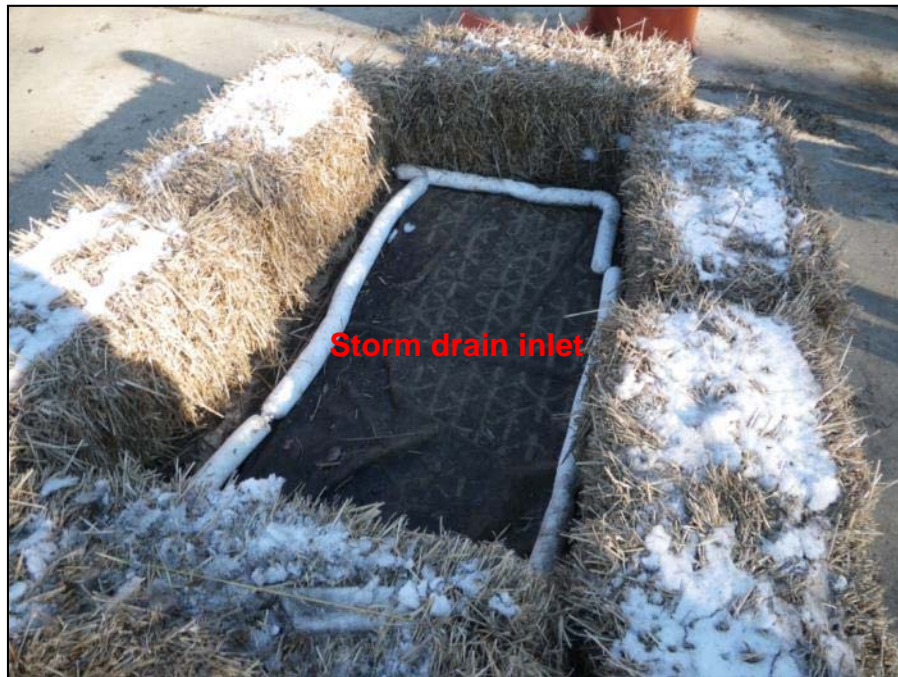
Photograph 61. 935 Spa Road – Closer view of one of the storm drain inlets noted in previous photograph.

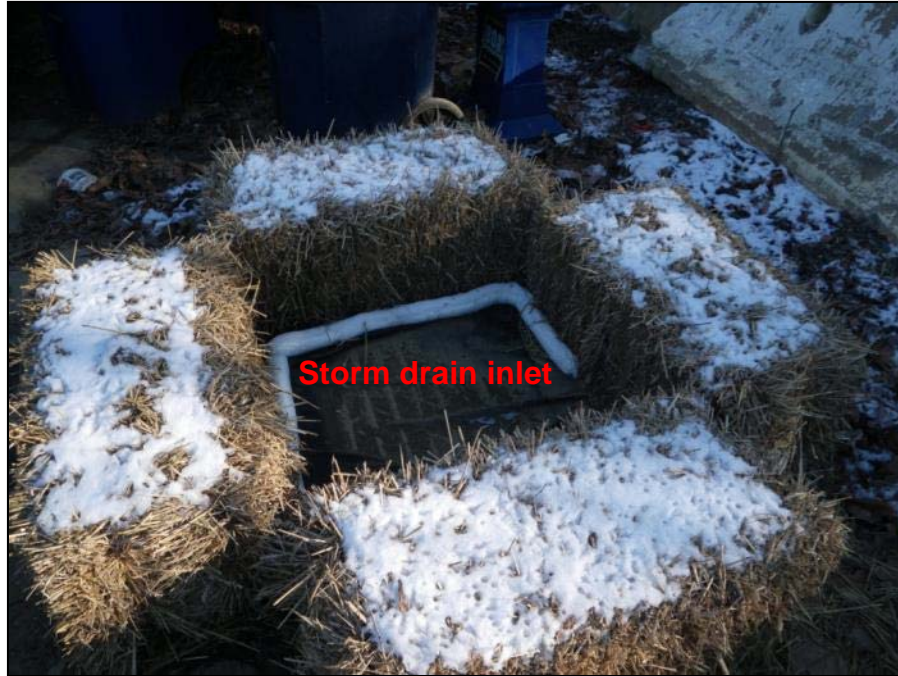
Photograph 62. 935 Spa Road – Closer view of other storm drain inlet noted in previous photographs.

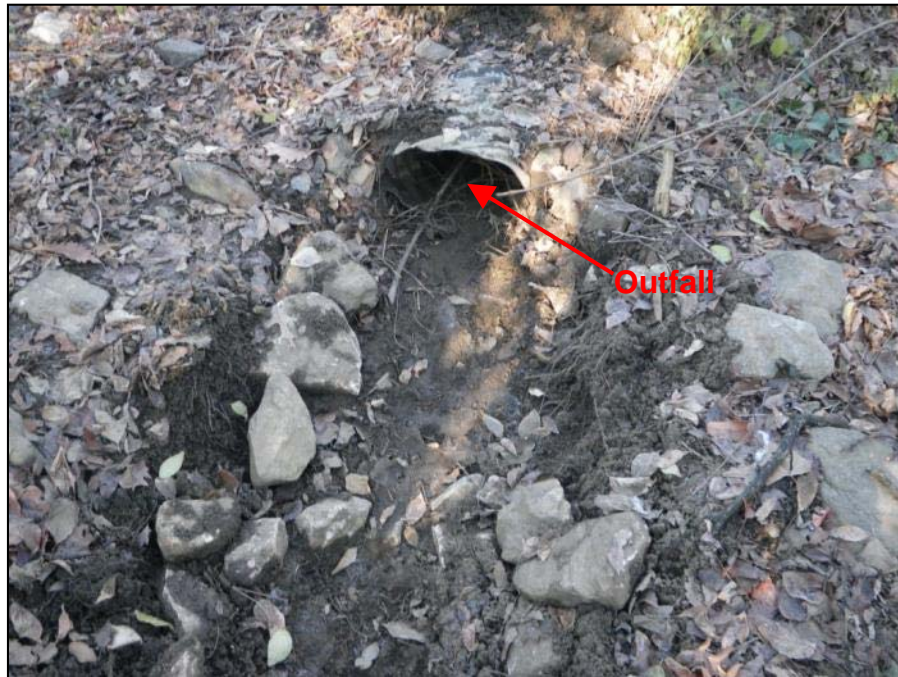
Photograph 63. 935 Spa Road – View of stormwater outfall that leads to Spa Creek.

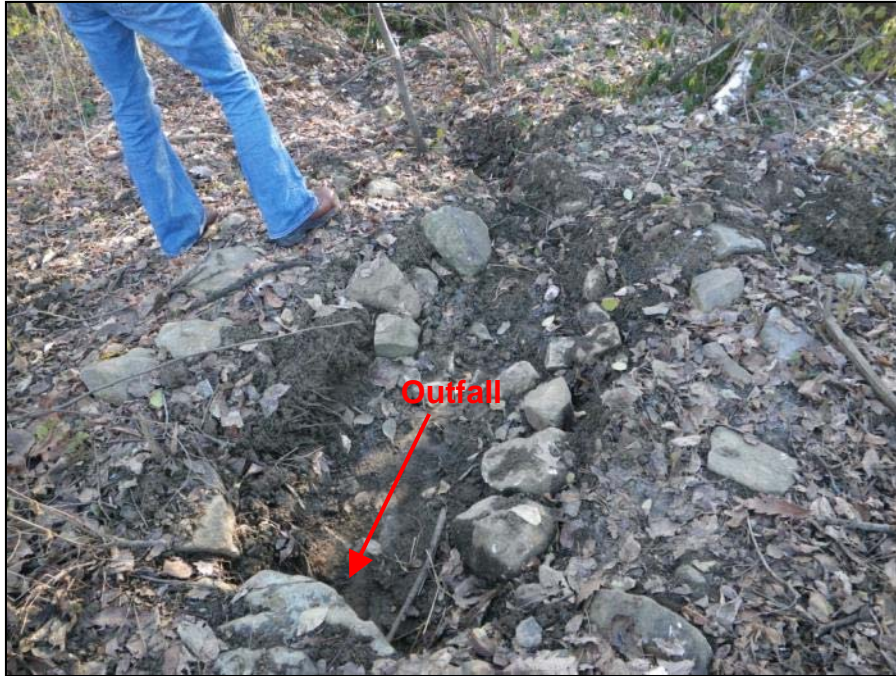
Photograph 64. 935 Spa Road – Additional view of stormwater outfall that leads to Spa Creek.

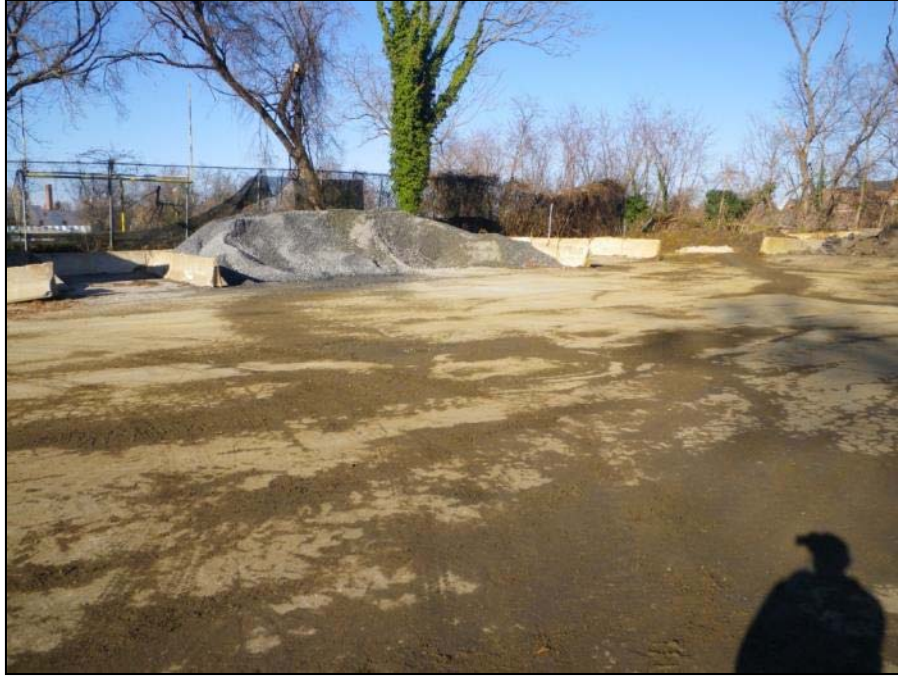
Photograph 70. 935 Spa Road – View of back storage yard located at the southeast side of the facility where street sweeping sorting activity occurs.

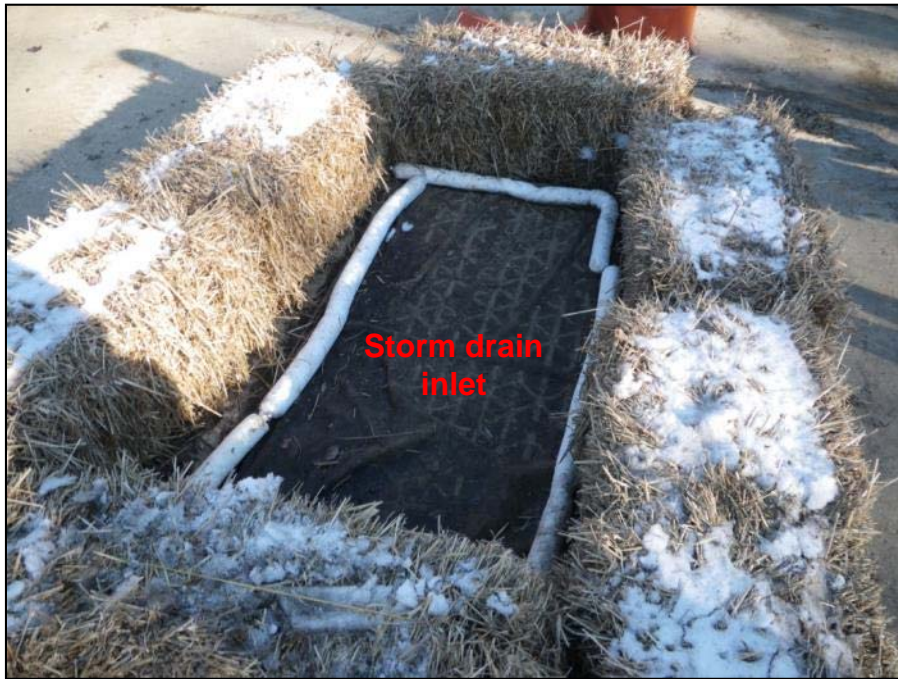
Photograph 71. 935 Spa Road – View of storm drain inlet in vicinity of where street sweeping sorting occurs.

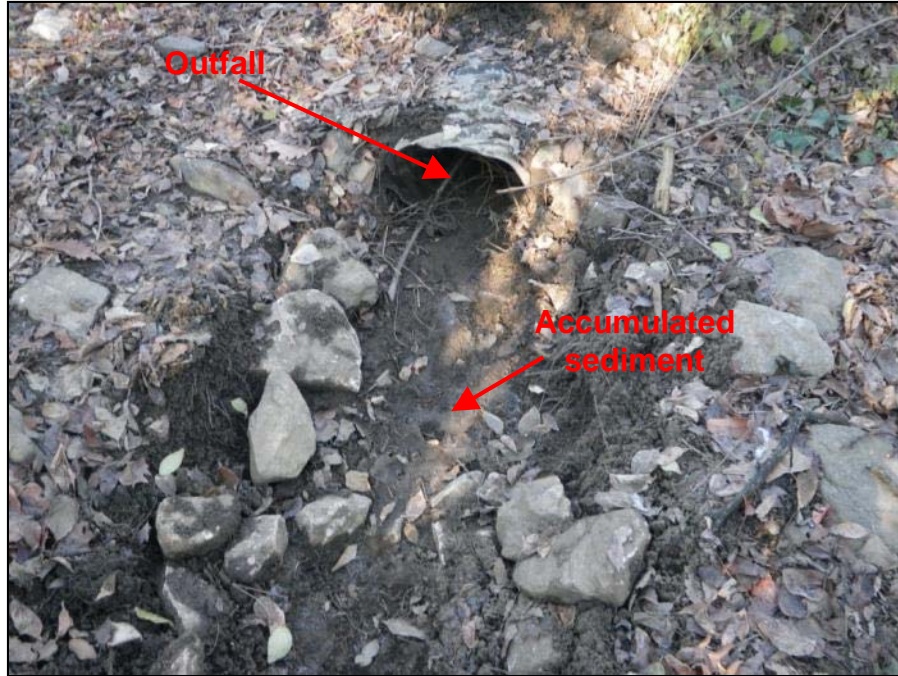
Photograph 72. 935 Spa Road – View of accumulated sediment in and around the outfall downgradient of storm drain inlet shown in previous photograph.

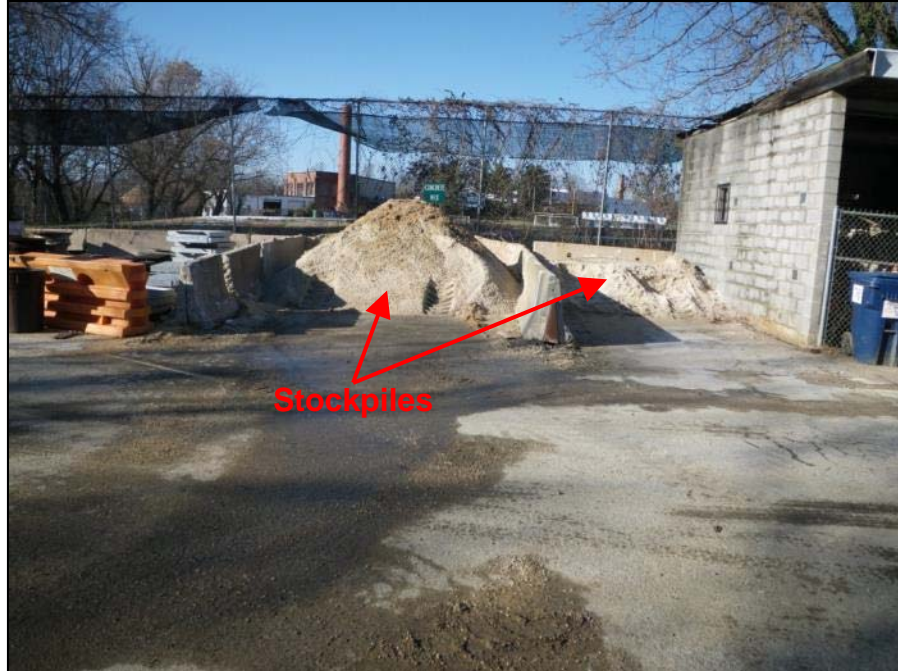
Photograph 73. 935 Spa Road – View of bulk material stockpile located in the back storage yard area located along the southeast side of the facility.

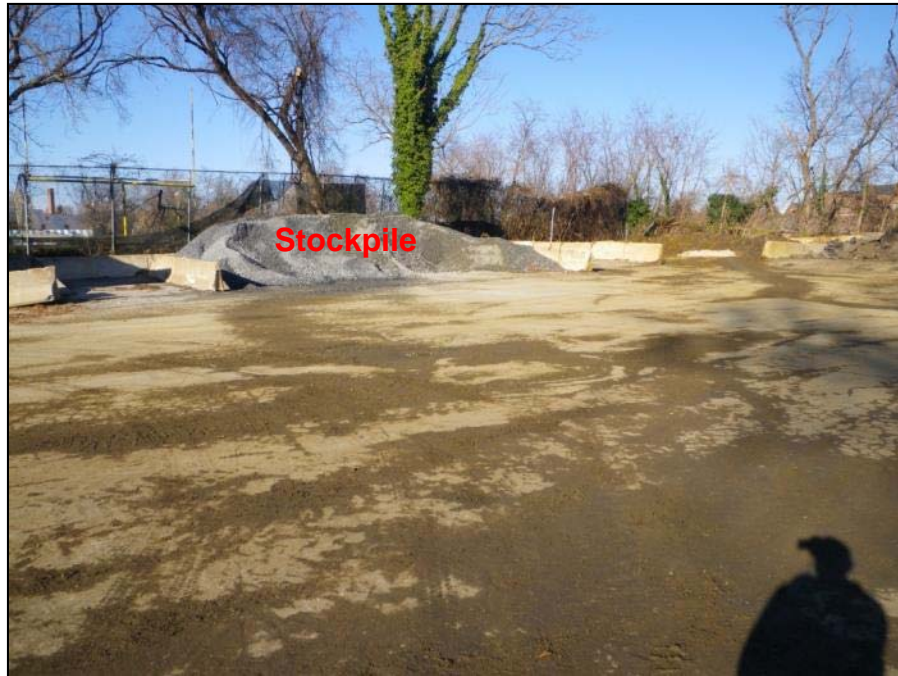
Photograph 74. 935 Spa Road – Additional example of bulk material stockpile located in the back storage yard area located along the southeast side of the facility.

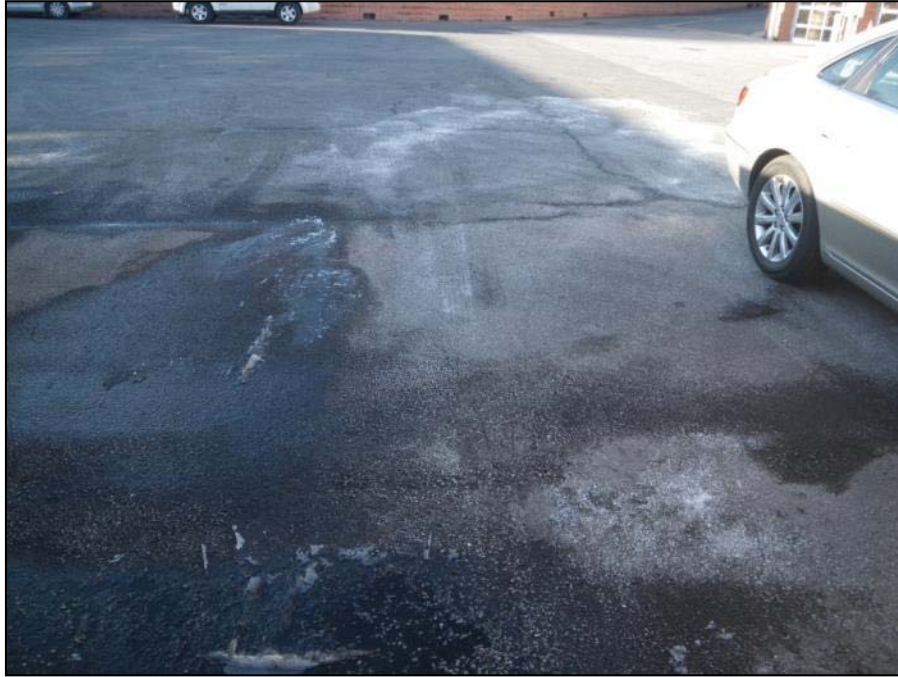
Photograph 75. View of area where vehicle washing was occurring at the time of the site visit.

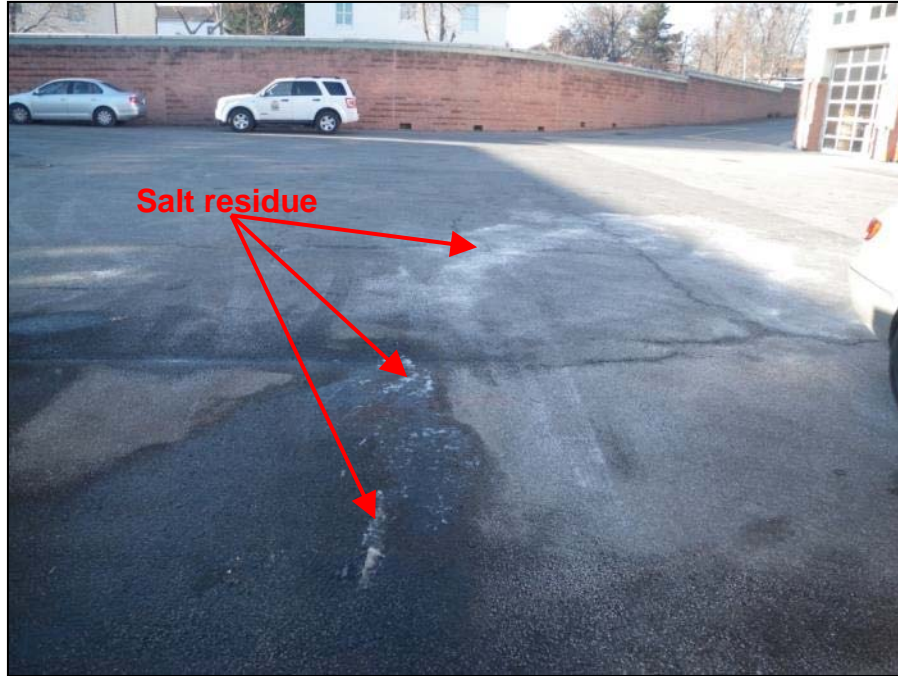
Photograph 77. View of salt residue on the impervious surface in the area where vehicle washing occurred.

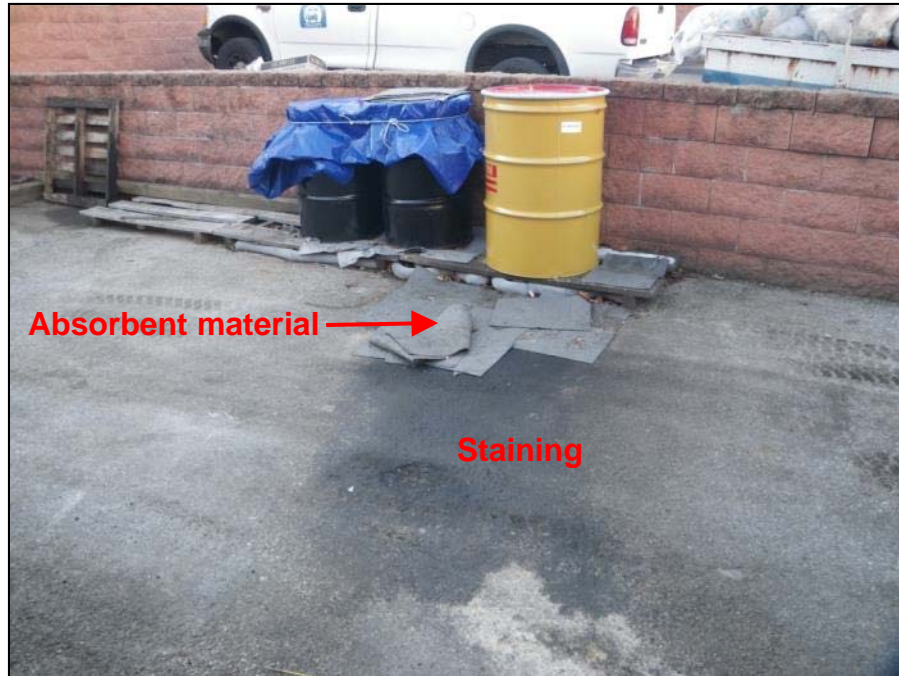
Photograph 83. View of absorbent material and staining located in the waste oil disposal and storage area.
